**O.Reg. 206/24 – Air Pollution – Discharge of Benzene from INEOS Styrolution  
Hourly (February 24, 2025) and 24-hour Benzene Exceedances (February 24, 2025)**

Ontario Regulation 206/24: Air Pollution – Discharge of Benzene from INEOS Styrolution (“O.Reg. 206/24”) requires a report to be submitted to the District Manager of the Ministry of the Environment, Conservation and Parks’ (“MECP”) Sarnia District Office, the Chief of the Aamjiwnaang First Nation (“AFN”), and the Ministry’s Spills Action Centre within 14 days after an exceedance notification. This report describes the benzene concentration measured at eGC#3 above 90 µg/m<sup>3</sup> over any hour that occurred on February 24, 2025, and above 30 µg/m<sup>3</sup> over the preceding 24-hour period on February 24, 2025 (MECP Reference #1-HUSLRB).

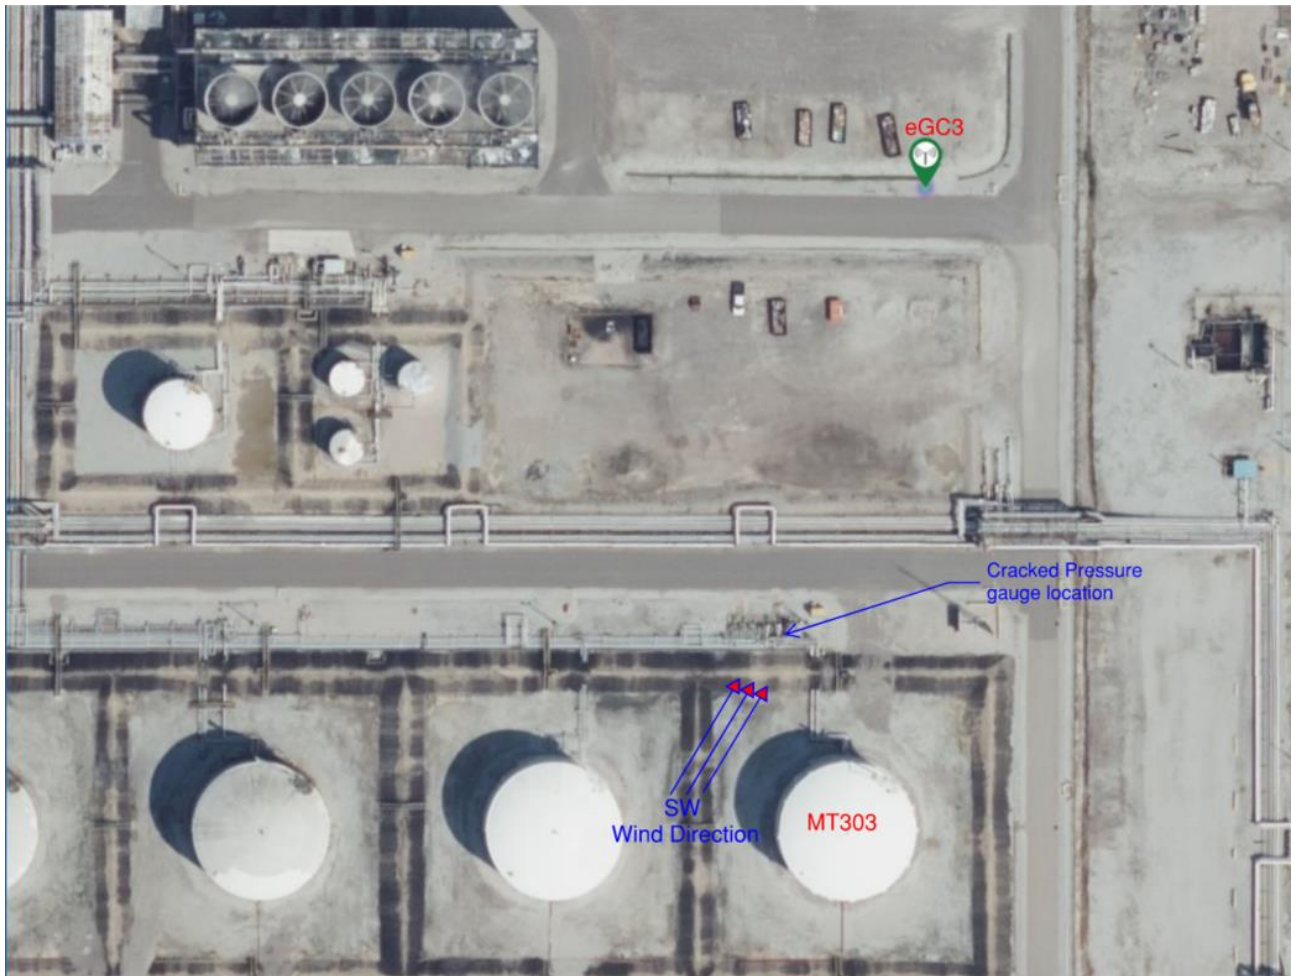
Figure 1: Aerial View of Contamination Area, eGC#3, and MT303

On the same day, around 20:30, the site received another elevated alert from eGC#3. Operations again inspected the area of MT303 and upon further investigation found a cracked pressure gauge on a benzene fill line to the tank that had released a small volume of liquid/ice Benzene. Operations

quickly responded by isolating both valves on either side of the pressure gauge. The diminutive volume of liquid/frozen Benzene was cleaned up, and securely stored in the hazardous waste laydown area. The waste storage area is being monitored to ensure no benzene emissions are being emitted while the site awaits waste pick-up. eGC#3 values steadily decreased to less than detectable. An aerial view of contamination location with eGC#3, MT-303 tank along with the wind direction is included (see Figure 1).

Root cause for the exceedance was determined to be the cracked pressure gauge due to moisture accumulation at a low point and freezing temperatures. It is theorized that the initial crack occurred in the pressure gauge around 8:30 in the morning when the first alert was received followed by the exceedance alerts later that night.

In conclusion, Operations will be conducting routine walkthroughs of the unit, inspecting for similar low points and other potential sources of benzene emissions in gauges and piping.

Corrective Action:	Implementation Date:
Investigation initiated after first exceedance alert.	February 24, 2025, 08:30: No contributing factors found.
Investigation resumed around tank MT303 after second alert to find any other potential sources of benzene.	February 24, 2025, 20:30: Elevated emissions coming from cracked pressure gauge on a benzene fill line to MT303 releasing diminutive volume of liquid/ice Benzene.
Cracked pressure gauge was isolated by blocking in valves on both sides.	February 24, 2025, 23:00 Reduced readings around MT303 fill line area, reduced readings at eGC#3 and ceased all alerts.
The diminutive volume of liquid/frozen benzene was cleaned up, and securely stored in the hazardous waste laydown area.	February 24, 2025, waste stored in the hazardous waste laydown area awaiting removal from site.
Operations to look for similar low points and other potential sources of benzene emissions in gauges and piping.	As a part of routine rounds, operations will check for drips, odours, leaks, in the entire area each shift (twice a day).
