**O.Reg. 206/24 – Air Pollution – Discharge of Benzene from INEOS Styrolution  
Hourly (March 19, 2025)**

**Summary of the Hourly Exceedance on March 19, 2025:**

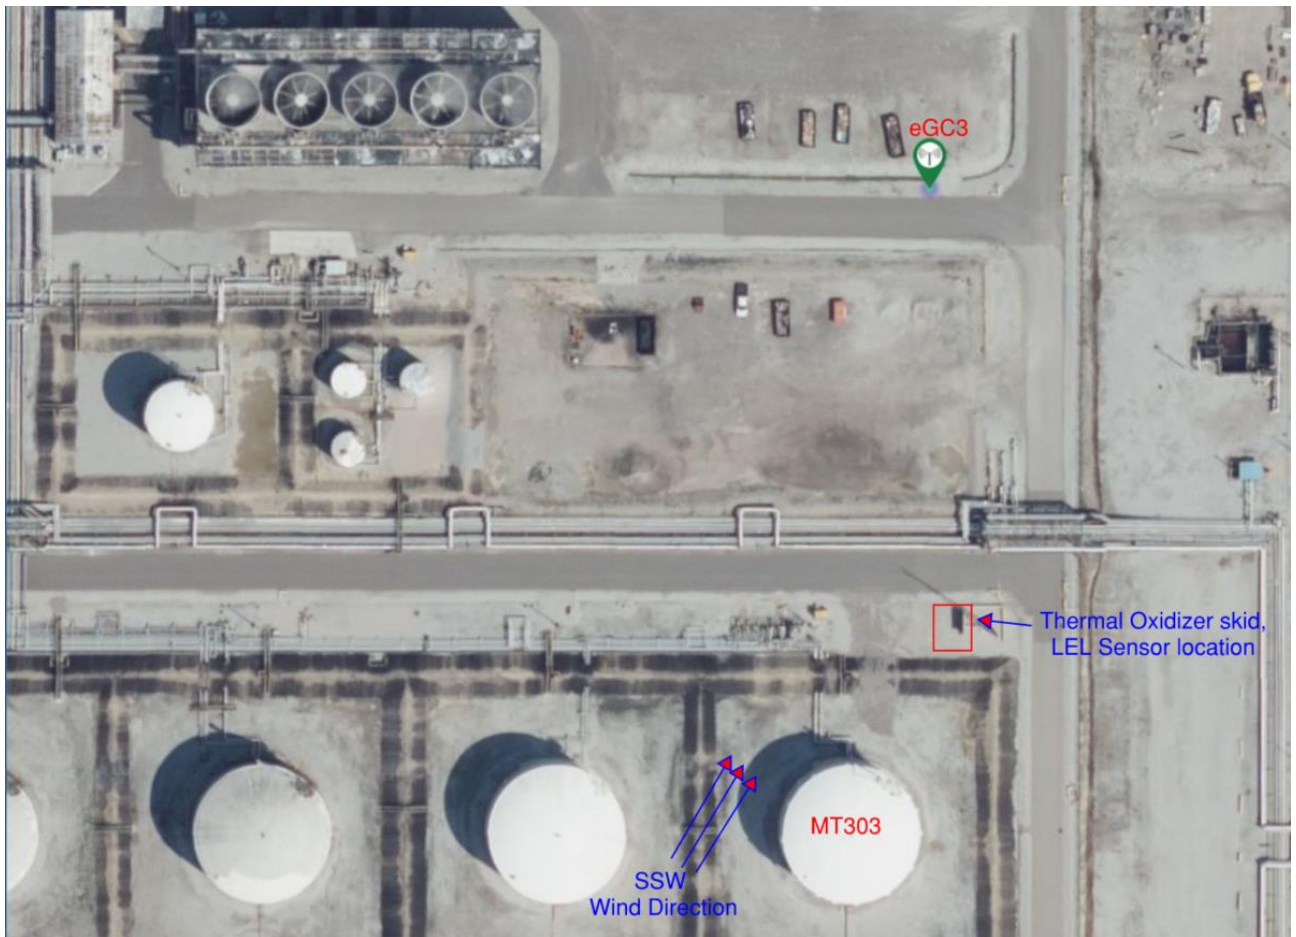
On March 19, 2025, at 12:00 the site received an exceedance alert from eGC#3. eGC#3 is located on the east side of Styrene II (see Figure 1) next to the hazardous waste laydown area. During this period, the site continues to be shutdown/idled with limited activity that would produce benzene emissions. Operations and monitoring technicians checked the area for potential sources of elevated benzene emissions. Various areas around eGC#3 (frac tanks, tanks, blower system, PP306 pumps) were checked and no measurable readings were detected. At this same time a frac tank in the hazardous waste laydown down area was being loaded with I-5 water. No elevated emissions were observed by the monitoring technician around this location.

On March 27<sup>th</sup> the site noted elevated eGC#3 readings (spikes though not an exceedance). Upon further investigation, a loose LEL sensor connection on the MT303 Thermal Oxidizer was found with elevated readings and was tightened, and elevated readings were no longer visible. It is believed that this was the likely contributor to the exceedance on March 19<sup>th</sup> and could have been transient at that point due to startup conditions of the thermal oxidizer. For reference, MT303 is a benzene storage tank at the Styrene II site that utilizes a thermal oxidizer with destruction efficiency of 99.9% to control emissions.

Figure 1: Aerial View of the Therma Oxidizer, eGC#3, and tank MT303 (including wind direction)

Corrective Action:	Implementation Date:
Investigation initiated after the exceedance alert.	March 19, 2025, 12:00: No contributing factors found.
Elevated readings (spikes below exceedance levels) at eGC#3 were noted on March 27, 2025, at 09:00. Further investigation uncovered that the LEL sensor fitting on MT303 TO had a loose connection and elevated handheld benzene readings were detected.	March 27, 2025, at 11:00: Tightened the sensor fitting. Reduced readings around MT303 Thermal Oxidizer skid area and elevated readings at eGC#3 ceased. The LEL connection was believed to be the cause of the March 19, 2025, exceedance. The tightening of the fitting should solve the problem.
