**O.Reg. 206/24 – Air Pollution – Discharge of Benzene from INEOS Styrolution
Hourly (June 24, 2025)**

Summary of the Hourly Exceedance on June 24, 2025:

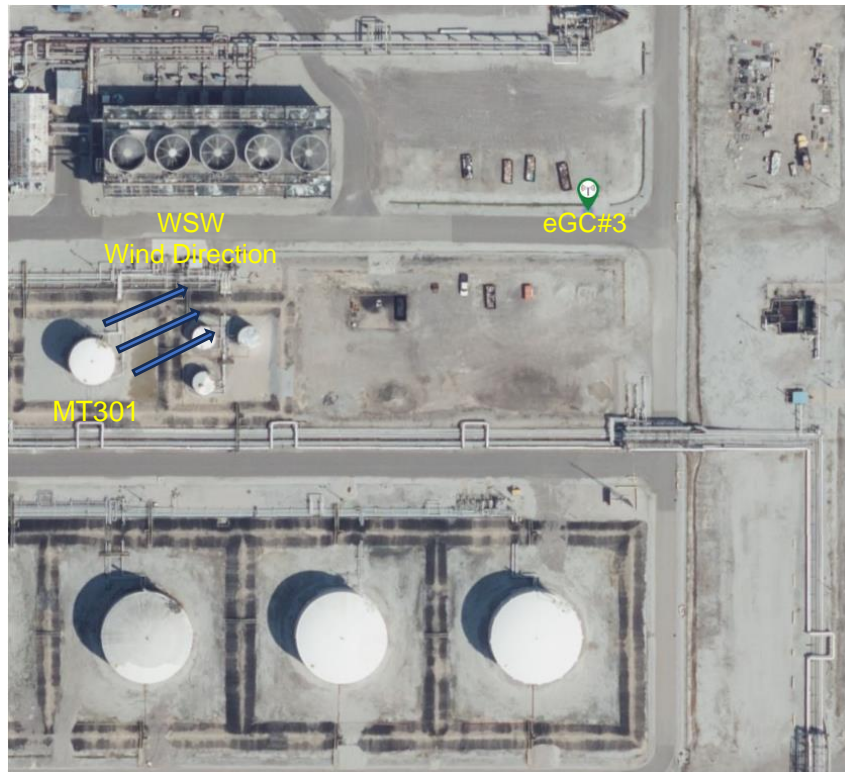
eGC#3 is located on the east side of Styrene II (see Figure 1) next to the hazardous waste laydown area. During this period, the site remains shutdown with process units and most piping decontaminated, and minimal activities occurring which could produce benzene emissions. The alert at eGC#3 was a single, 10-minute spike at 09:10 that caused an exceedance of the hourly rolling average threshold of 90µg/m³ (see Figure 2). Our third-party consultant confirmed that the unit calibrations passed and that the reading appeared valid.

On June 24, 2025, at 09:25, the site received an exceedance alert from eGC#3. At that time, an oily water vacuum truck was offloading material into tank MT301, which has internal floating roof control designed to reduce vapour emissions and loss in storage tanks. Operations immediately stopped all work when the alert was received and checked various other sources around eGC#3 as potential benzene source contributors and no other benzene emissions, equipment leaks, or equipment malfunctions were identified. Given the wind direction and the proximity to eGC#3, it is believed that normal rim and deck seal losses from tank MT301 was the cause of the increased benzene emissions. Tank transfers into MT301 was stopped and Operations is currently working to connect tank MT301 to the thermal oxidizer located at MT303 to further control tank benzene emissions moving forward.

Figure 1: Aerial view of eGC#3 and the proximity of tank MT301 (including wind direction)

Corrective Action:	Implementation Date:
Investigation initiated after the exceedance alert was received.	June 24, 2025.
Investigation around eGC#3 to find any potential sources of benzene that may have contributed to the exceedance.	June 24, 2025. Elevated emissions from tank fittings at the top of tank MT301 believed to be the source of increased emissions.
Stopped transferring oily water into tank MT301.	June 24, 2025. The transferring of oily water into tank MT301 was stopped, reduced readings at eGC#3 observed, and no other alerts received.
Connect and commission tank MT301 to the thermal oxidizer at MT303.	Week ending July 11, 2025.

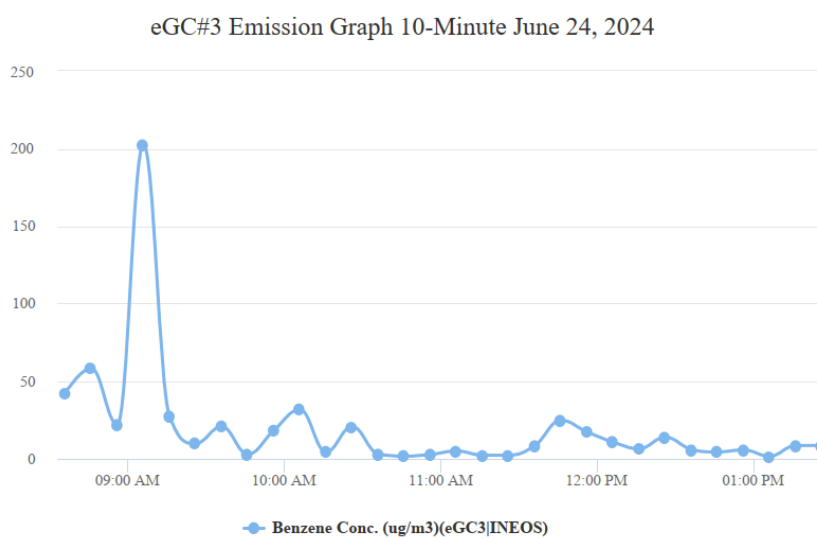
Time Period	Measured Benzene Concentration (Rolling Hourly Average - µg/m³)	Wind Direction	Wind Speed (km/hr)
09:10	97.6	WSW	8.2

Figure 2: eGC#3 10-minute benzene emission graph capturing the elevated reading that skewed the hourly-average
