**O.Reg. 206/24 – Air Pollution – Discharge of Benzene from INEOS Styrolution  
Hourly (Oct 12, 2025)**

**Summary of Hourly Exceedances on Oct 12, 2025:**

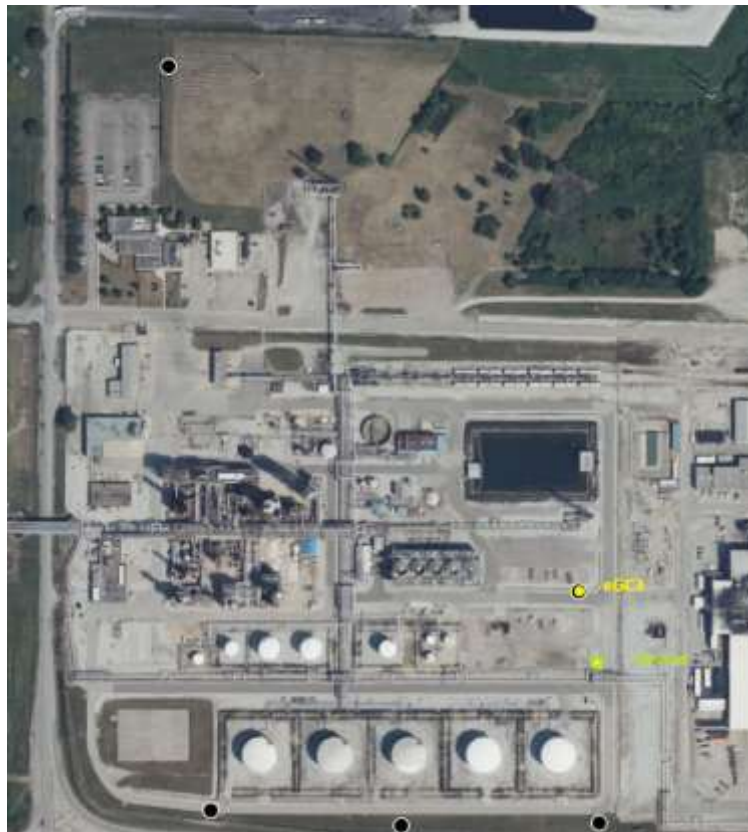
On October 12<sup>th</sup>, 2025, at 19:30, the site received an exceedance alert from eGC#3. Other eGC’s had shown intermittent values as well, indicating that the value from eGC#3 was likely valid; and this was later confirmed by our third party contractor. Operations and monitoring technicians checked the area for potential sources of elevated benzene emissions. There were no odours, adjacent vac boxes did not show elevated values around connections, and MT303 area showed no readings. Upon further investigation, a 3<sup>rd</sup> party line that had been recently air gapped (valve removed) showed ~1ppm benzene at the opening (see Figure 1). The pipe opening was quickly wrapped and the eGC readings quickly diminished.

Root cause for the exceedance was determined to be emissions from an open 3<sup>rd</sup> party line that had not been adequately cleared and isolated by the 3<sup>rd</sup> party. After positively isolating this source, eGC#3 showed readings near background levels.

Figure 1: Aerial View of eGC3 and the proximity of the Source

| Corrective Action: | Implementation Date: |
|---|---|
| Temporarily wrapped 3 <sup>rd</sup> party pipe source to reduce emissions. | Completed October 12, 2025 |
| Install physical isolation (blind flange). | Completed October 13, 2025 |
| Third party to further evacuate/clear any material and positively isolate (new blind flange) | Completed October 16, 2025 |
| Site Monitoring Tech to check other periphery air gapped lines for benzene emissions | Due October 31, 2025 |
