**O.Reg. 206/24- Air Pollution – Discharge of Benzene from INEOS Styrolution 1-Hour Benzene Limit Exceedance (August 28, 2024)**

Ontario Regulation 206/24: Air Pollution – Discharge of Benzene from INEOS Styrolution requires a report to be submitted to the Ministry of the Environment, Conservation and Parks District Manager of the Sarnia District Office, the Chief of the Aamjiwnaang First Nations (or designate), and a provincial officer at the Ministry’s Spills Action Centre within 14 days after an exceedance notification. This report describes the discharge above 90 µg/m<sup>3</sup> over a one-hour period that occurred on August 28, 2024, at eGC#3 (MECP Reference #1-AVHIY5).

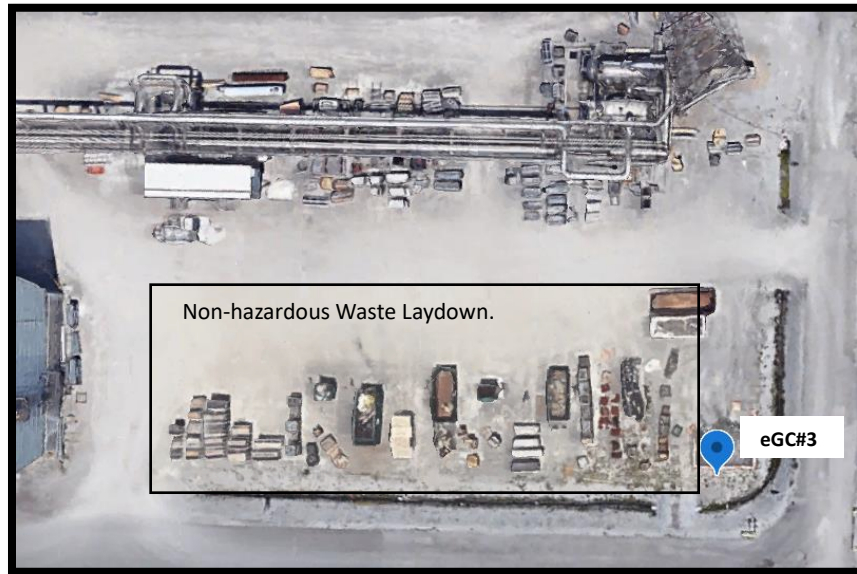
The investigation concluded that beginning at 08:00, a fork truck was being utilized in the non-hazardous waste laydown area to move wood and metal material in the vicinity of eGC#3 for approximately 15 minutes. The fork truck operator stated that the equipment was misfiring and had visible exhaust, and the fork truck had to be shut off and turned back on multiple times. The fork truck primary fuel source is propane so it is not expected that benzene emissions

**Figure 1:** Map of eGC#3 and the area the fork truck was operating in.

Corrective Action:	Implementation Date:
Complete investigation	September 11, 2024
Install barricade around eGC#3 to prevent machinery from getting too close and install a 'NO IDLING' sign in the non-hazardous waste laydown area	Installed on October 3, 2024.
Conduct training for contractors and onsite personnel regarding the eGCs and the implications of operating motor vehicles/equipment within the vicinity of the eGC.	Training was completed for site personnel on October 8, 2024.
Review mobile source/vehicle maintenance practices for site and contractor equipment to identify improvements or adjustment to frequency	A review was completed on October 22, 2024, determining that maintenance (PM and repairs) were sufficient for the forklifts on site.

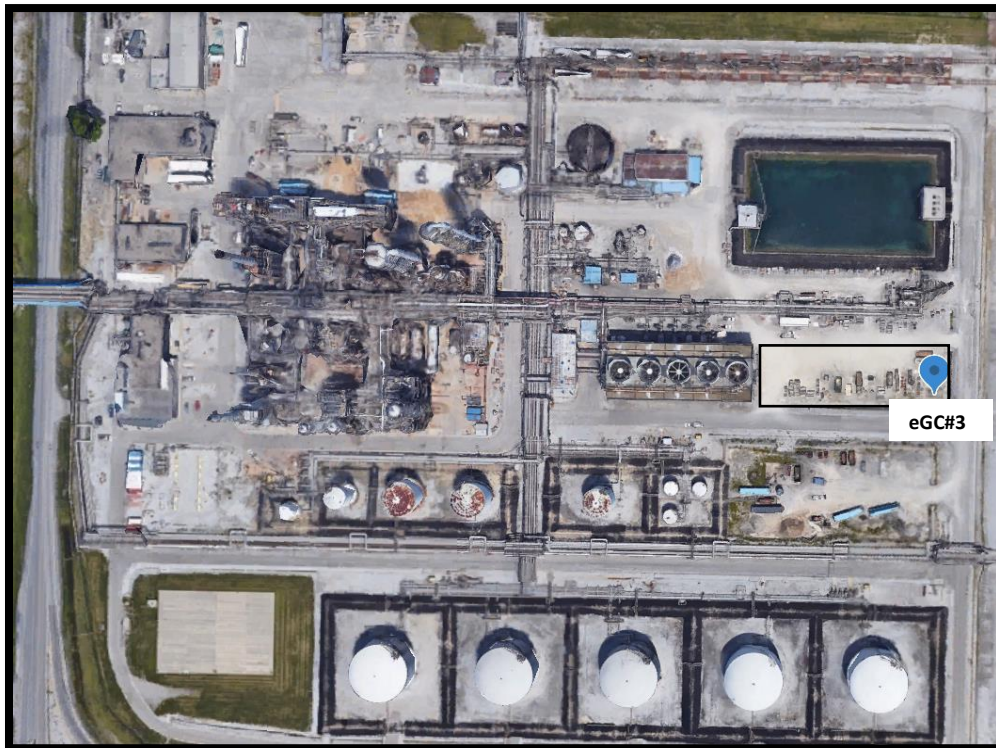
**Figure 2:** Area fork truck was operating in relation to the whole INEOS Styrolution Sarnia Site.

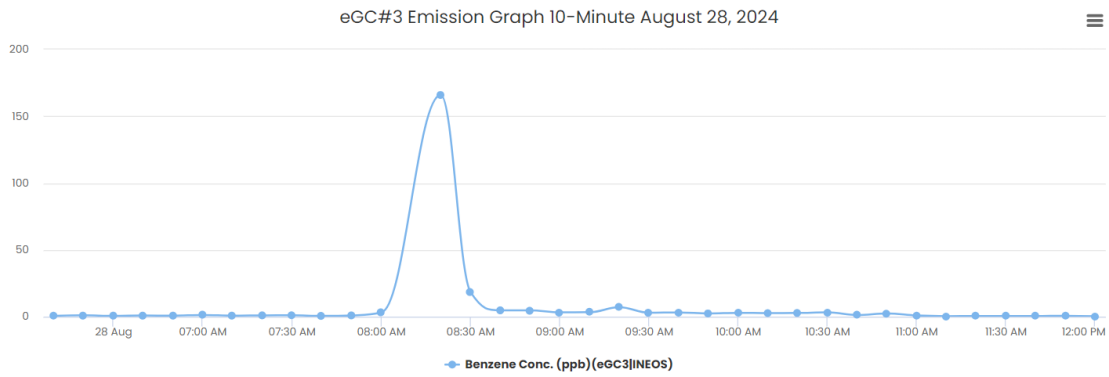
At 09:00 a notification from eGC#3 alerted the site due to an elevated hourly benzene concentration of 39.39ppb. Activities on-site were halted to investigate. Personnel with handheld monitors were immediately deployed to assist with locating a possible source of the alert. The eGC Dashboard displayed that the cause of the elevated concentration was a one, 10-minute spike at 08:15 over the period of an hour.

**Figure 3:** A ten-minute benzene emission graph for eGC#3 capturing the elevated reading which skewed the hourly-average.

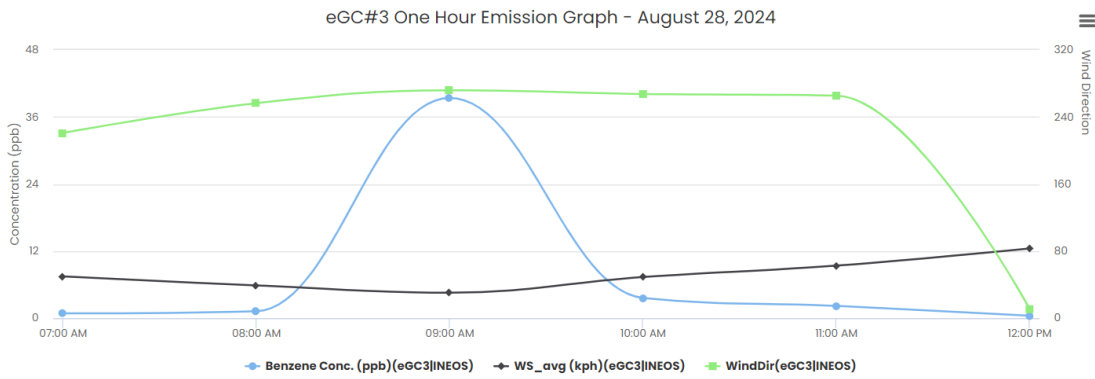
**Figure 4:** A 1-Hour benzene emission graph for eGC#3.

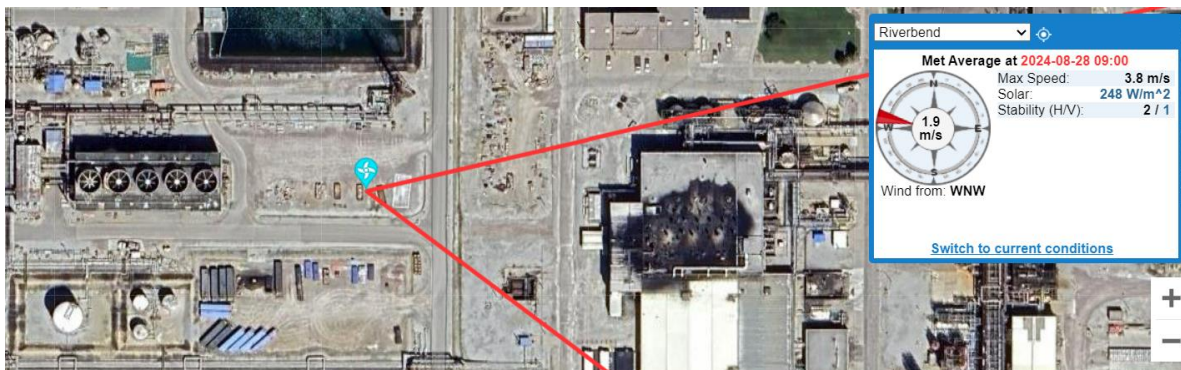
**Figure 5:** The wind direction at the time of the alert.
