**O.Reg. 206/24 – Air Pollution – Discharge of Benzene from INEOS Styrolution
Hourly (August 28, 2025)**

Ontario Regulation 206/24: Air Pollution – Discharge of Benzene from INEOS Styrolution (“O.Reg. 206/24”) requires a report to be submitted to the District Manager of the Ministry of the Environment, Conservation and Parks’ (“MECP”) Sarnia District Office, the Chief of the Aamjiwnaang First Nation (“AFN”), and the Ministry’s Spills Action Centre within 14 days after an exceedance notification. This report describes the benzene concentration measured at eGC#3 above 90 µg/m³ over any hour that occurred on August 28, 2025 (MECP Reference #1-PFLZ6P).

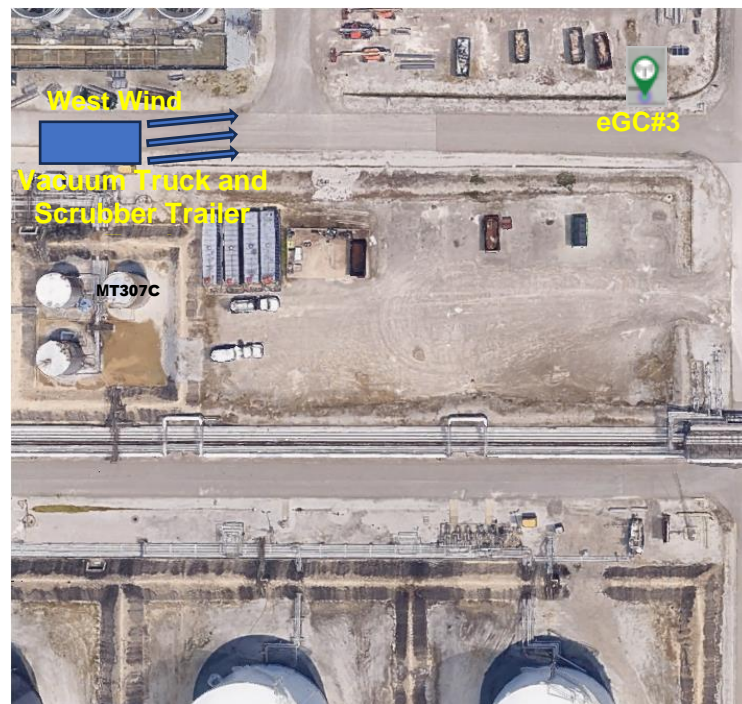
Figure 1: Aerial view of eGC#3 and the proximity of Vacuum Truck and Scrubber Trailer (including wind direction)

eGC#3 is located on the east side of Styrene II (see Figure 1) next to the hazardous waste laydown area. During this period, the site remains shutdown with process units and most piping decontaminated and minimal activities occurring which could produce benzene emissions. The alert at eGC#3 was a single, 10-minute spike at 11:30 that caused an exceedance of the hourly rolling average threshold of 90µg/m³ (see Figure 2). Our third-party consultant confirmed that the unit calibrations passed and that the reading appeared valid.

On August 28, 2025, a third party contractor was on site to remove waste material from inside of a vacuum box located on the road, adjacent to tank MT307C, due west from eGC#3. As per INEOS’ procedure, onsite handheld monitoring was being carried out every 30 minutes. Prior to receiving the email alert from eGC#3, an elevated value was measured using a handheld tiger select monitor that warranted Operations to immediately stop all work. During the investigation and given the wind direction and proximity to eGC#3, it was determined that, although a vacuum truck equipped with an attached carbon scrubber trailer was being used to control emissions during this activity, carbon breakthrough still occurred which caused the single spike at eGC#3, which in turn caused the rolling hourly average exceedance. INEOS personnel will continue monitoring at increased intervals for benzene emissions using the robust site monitoring program when third party work is being performed.

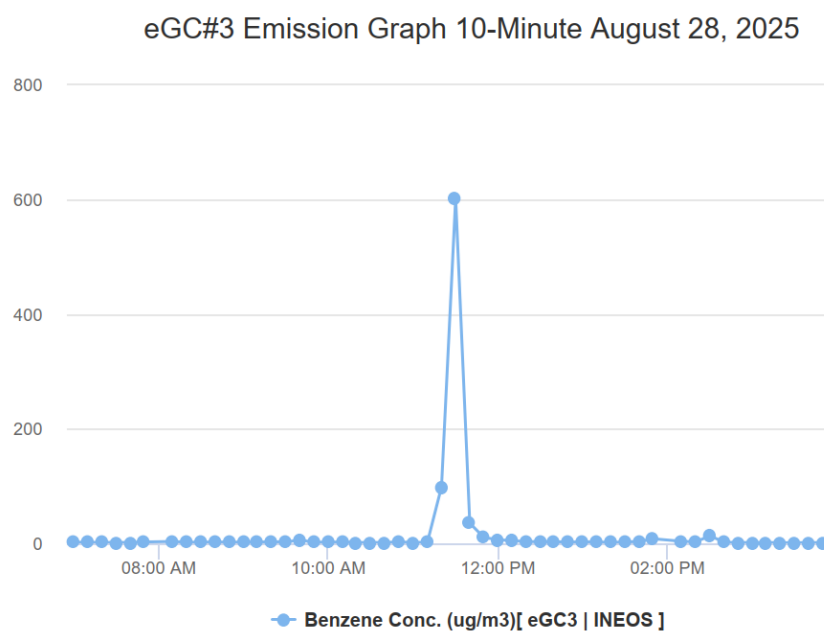
Figure 2: eGC#3 10-minute benzene emission graph capturing the elevated reading that skewed the hourly-average

Time Period	Measured Benzene Concentration (Rolling Hourly Average - µg/m³)	Wind Direction	Wind Speed (km/hr)
12:00	124.72	W	9.25
