## O.Reg. 206/24 – Air Pollution – Discharge of Benzene from INEOS Styrolution (June 11-13, 2025)

Ontario Regulation 206/24: Air Pollution – Discharge of Benzene from INEOS Styrolution ("O.Reg. 206/24") requires a report to be submitted to the District Manager of the Ministry of the Environment, Conservation and Parks' ("MECP") Sarnia District Office, the Chief of the Aamjiwnaang First Nation ("AFN"), and the Ministry's Spills Action Centre within 14 days after an exceedance notification. This report describes the benzene concentration on the eGCs above 90  $\mu$ g/m<sup>3</sup> over any hour or 30  $\mu$ g/m<sup>3</sup> over any rolling 24-hour period that occurred during the period of June 11-13, 2025 (MECP Reference #1-OKFOLL and 1-OKR2B).

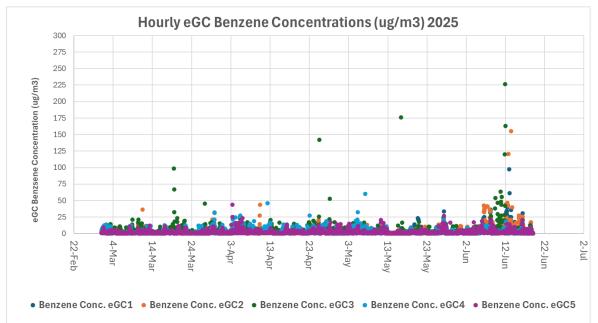
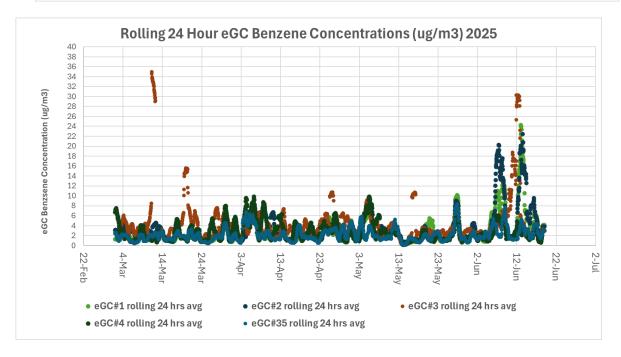
Figures: eGC hourly and rolling 24 hour benzene emission graph

Time Period	Measured Benzene Concentration	Wind Direction	Wind Speed
	(Rolling Hourly Average - µg/m <sup>3</sup> )		(km/hr)
June 11, 2025; 20:00	eGC#3 - 119.98	SW	8.96
June 11, 2025; 22:00	eGC#3 – 226.55	W	3.18
June 11, 2025; 23:00	eGC#3 – 163.14	SW	5.62
June 12, 2025; 17:00	eGC#2 – 120.65	E	8.45
June 12, 2025; 23:00	eGC#1 – 97.71	ENE	5.69
June 13, 2025; 11:00	eGC#2 – 155.00	ENE	10.24

Time Period	Measured Benzene Concentration (Rolling 24-hour Average - μg/m³)	Wind Direction	Wind Speed (km/hr)
June 11, 2025; 23:06	eGC#3 – 30.73	SE	10.48

The exceedances occurred due to cumulative impact of various activities and emissions sources related to the site decommissioning. A key contributor was the temporary cooling system provided by the external contractor. This system consisted of two heat exchangers and a knock-out drum, intended to cool the mixed steam (with added chemistry)/hydrocarbon stream before it entered a tank for separation. This system was vented to flare to remove any light or non-condensable material. The temporary system was not able to adequately cool the process steam, resulting in

hotter effluent to the tank, and hotter cooling water to the sewer system. Based on process data and handheld readings obtained over the course of the three days, the evidence suggests that there were the following cumulative sources leading to the exceedances:

- 1. Hotter water to the sewer system produced emissions from historical contamination.
- 2. A hotter process stream resulted in a higher temperature in MT-301, which resulted in elevated emissions, despite its internal floating roof control system.
- 3. Fugitive leaks in the piping/equipment, which were promptly detected and rectified.
- 4. Increased flaring, as part of the removal of hydrocarbon from the system
