# Tylstrup Onshore Wind Farm

PPG's coating solution is still effective and intact after 20 years in service

## Case study

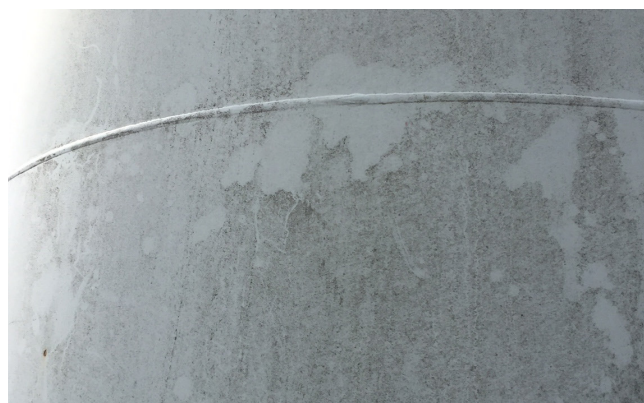
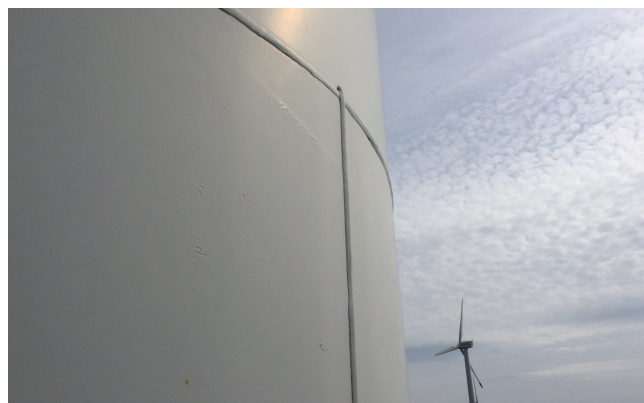
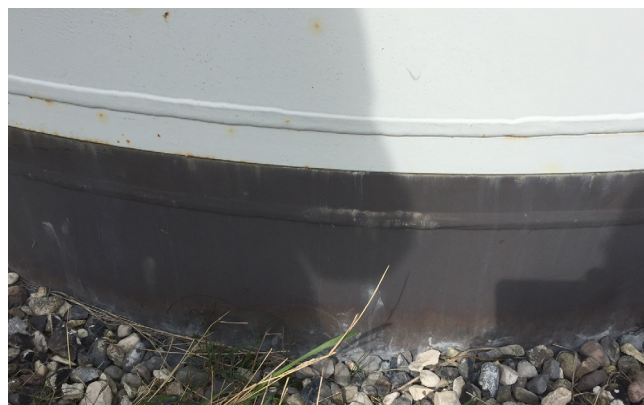
After nearly 20 years in service, a thorough inspection was carried and the wind towers were still in excellent condition with no coating breakdown, yet some only some chalking and algae on the north sides (see picture).

The initial dryfilmthickness as pr. specification (260µ dft for the outside) is still intact – with an average of 320µ dft measurement on the towers inspected.

Gloss level was down to ca. 5, vs. initial expected gloss level of a newly applied PPG SIGMADUR 520 would be ca. 40-50. However, PPG is satisfied that a conventional polyurethane semi-gloss topcoat as the coating is intact corrosion wise and the color retention outstanding.
