1.	Introduction to mining project.....	1-4
1.1.	History of operations	1-4
1.2.	Current development consents, leases and licences	1-5
1.3.	Land ownership and land use	1-6

Figure 1 Land ownership and land use
Tallawang Magnetite Mine Rehabilitation Management Plan 2022

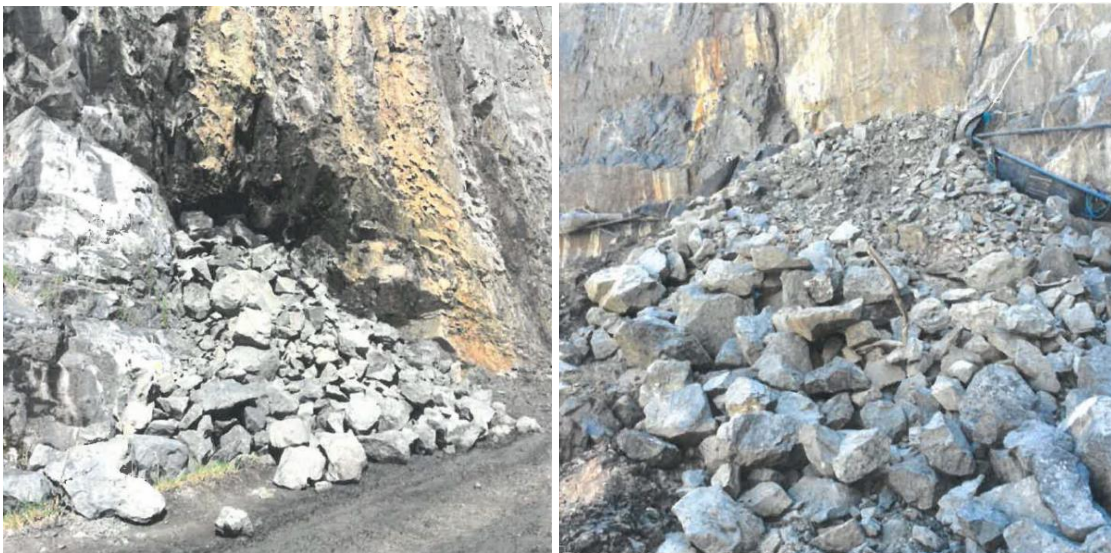
Figure 6 Photographs of the sealing of the underground portal

The underground mine has been permanently sealed in preparation for final land use (water management) as shown in Figure 6. This complied with MA0003/2006 DA 105/85 Condition 2 – Commitments in the EIS that all underground portals will be sealed to the satisfaction of the Department of Mineral Resources. The vent fan has been removed and replaced with a steel grid designed to restrict access. All other access points to the underground are back filled with earthen materials to restrict access (Sibelco, 2017b).

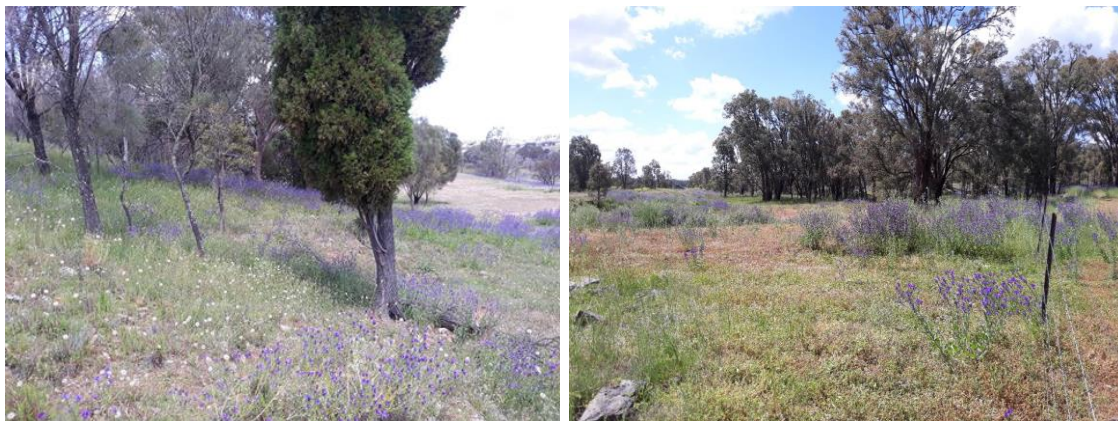
Figure 7 Pasture and shade tree establishment on overburden emplacement area (left) and former soil stockpile (right) (October 2020)

The suitability of the growing medium across the final landforms has been confirmed with successful establishment and vigorous growth of mixed pasture species and the return of soil function (ELA, 2021) (see Figure 7 and Figure 8).

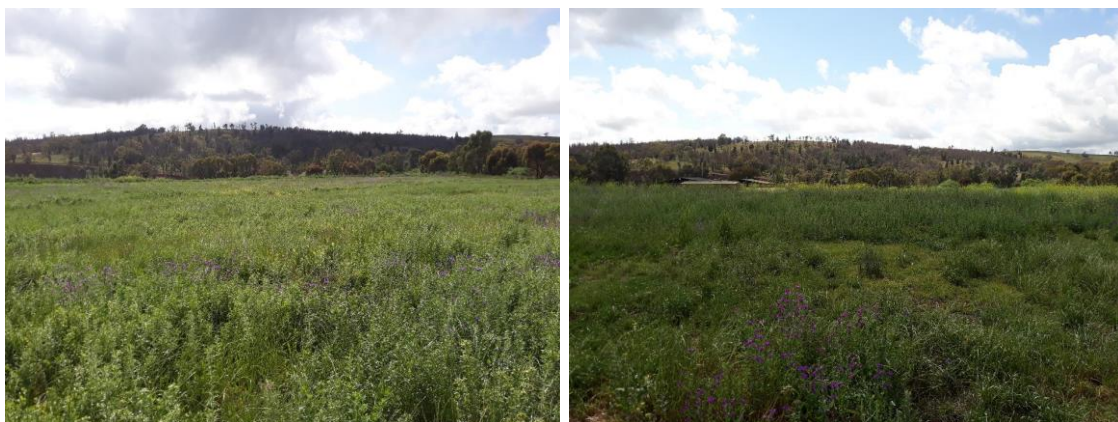
Figure 8 Pasture establishment on the former stockpiled black sand area on the TSF (left) and TSF Cell 2 (right) (October 2020)
