# Tallawang Magnetite Mine

## Rehabilitation Management Plan

Mine Name	Tallawang Magnetite Mine				
Holder	Sibelco Australia Limited PO Box 47 Dunwich, QLD, 4183				
Authority	Authority	Expiry			
	PLL 3610 (1906)	3 April 2024			
	PLL1093 (1906)	3 April 2024			
	ML6023 (1906)	3 April 2024			
	ML1241 (1991)	3 April 2024			
	MPL265 (1991) ML1652 (2011)	3 April 2024 20 January 2032			
Commencement Date	1 August 2022				
Document control					
No.	Description	Author	Review	Approved	Date
1	RMP (Version 1)	P. Shine R. Firmer	A. Butler R. Murray	P. Dunn	07/10/2022
2	RMP (Version 2)	P. Shine R. Firmer	M.Goldner	D. Paton	04/04/2024

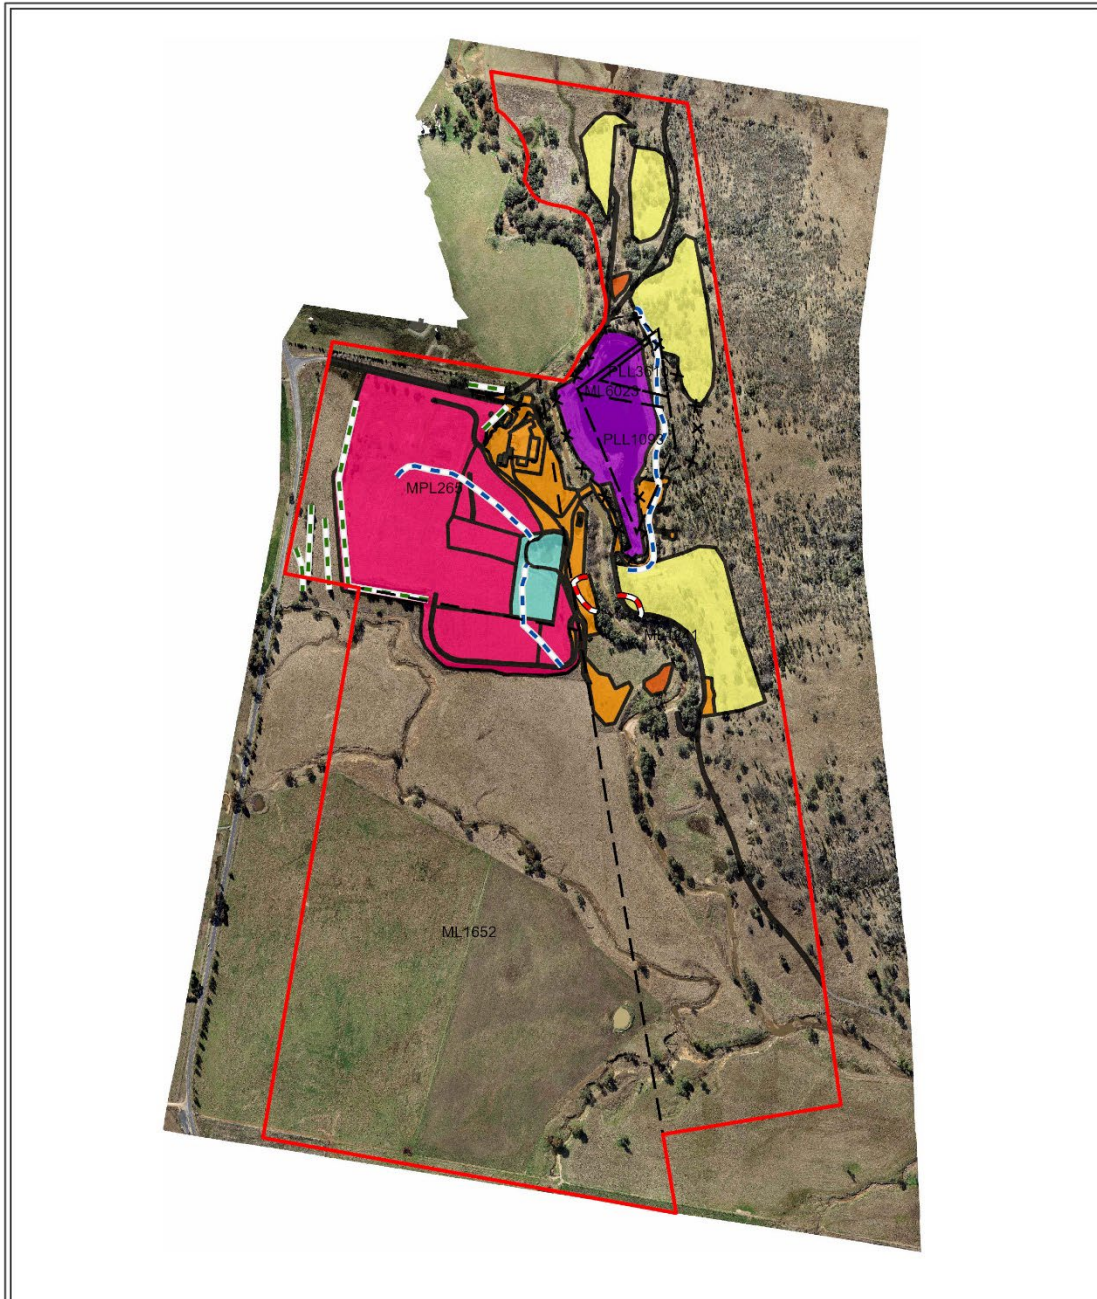
**Figure 2 Disturbance and Former Mining Domains**

**Figure 2 Disturbance and former mining domains at Tallawang**

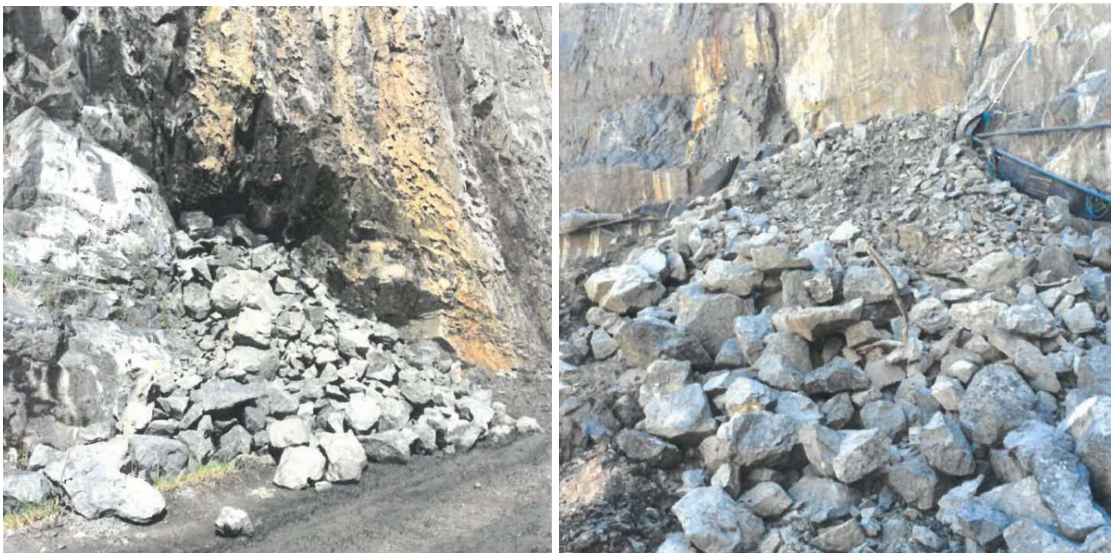
**Figure 6 Photographs of the sealing of the underground portal**

The underground mine has been permanently sealed in preparation for final land use (water management) as shown in Figure 6. This complied with MA0003/2006 DA 105/85 Condition 2 – Commitments in the EIS that all underground portals will be sealed to the satisfaction of the Department of Mineral Resources. The vent fan has been removed and replaced with a steel grid designed to restrict access. All other access points to the underground are back filled with earthen materials to restrict access (Sibelco, 2017b).

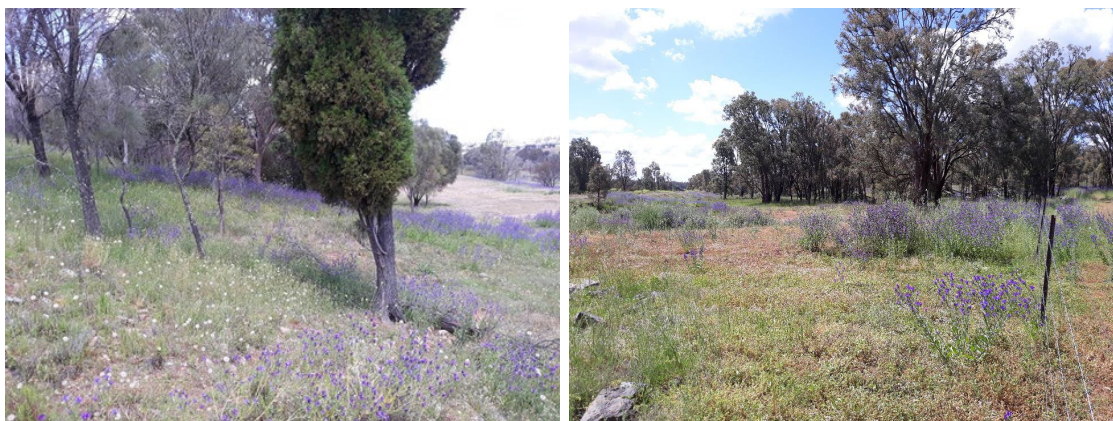
**Figure 7 Pasture and shade tree establishment on overburden emplacement area (left) and former soil stockpile (right) (October 2020)**

The suitability of the growing medium across the final landforms has been confirmed with successful establishment and vigorous growth of mixed pasture species and the return of soil function (ELA, 2021) (see Figure 7 and Figure 8).

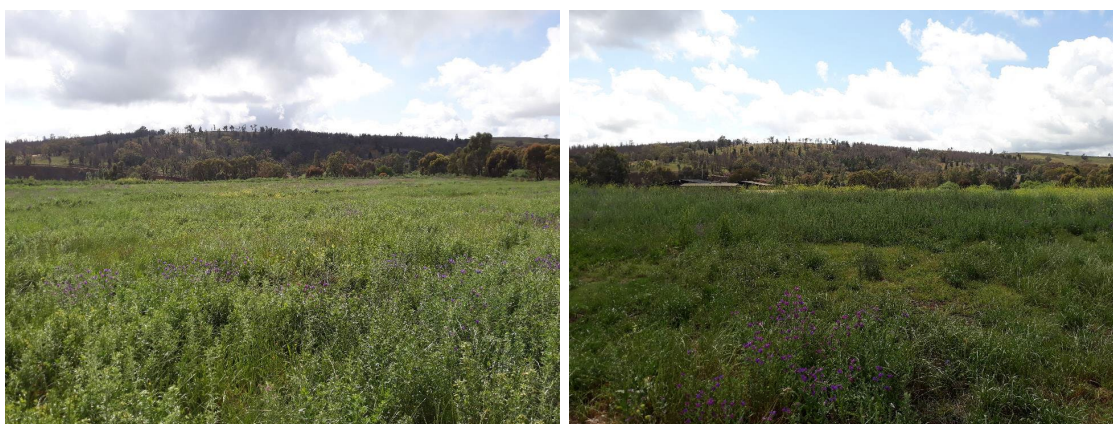
**Figure 8 Pasture establishment on the former stockpiled black sand area on the TSF (left) and TSF Cell 2 (right) (October 2020)**
